REGULATOR BOARD

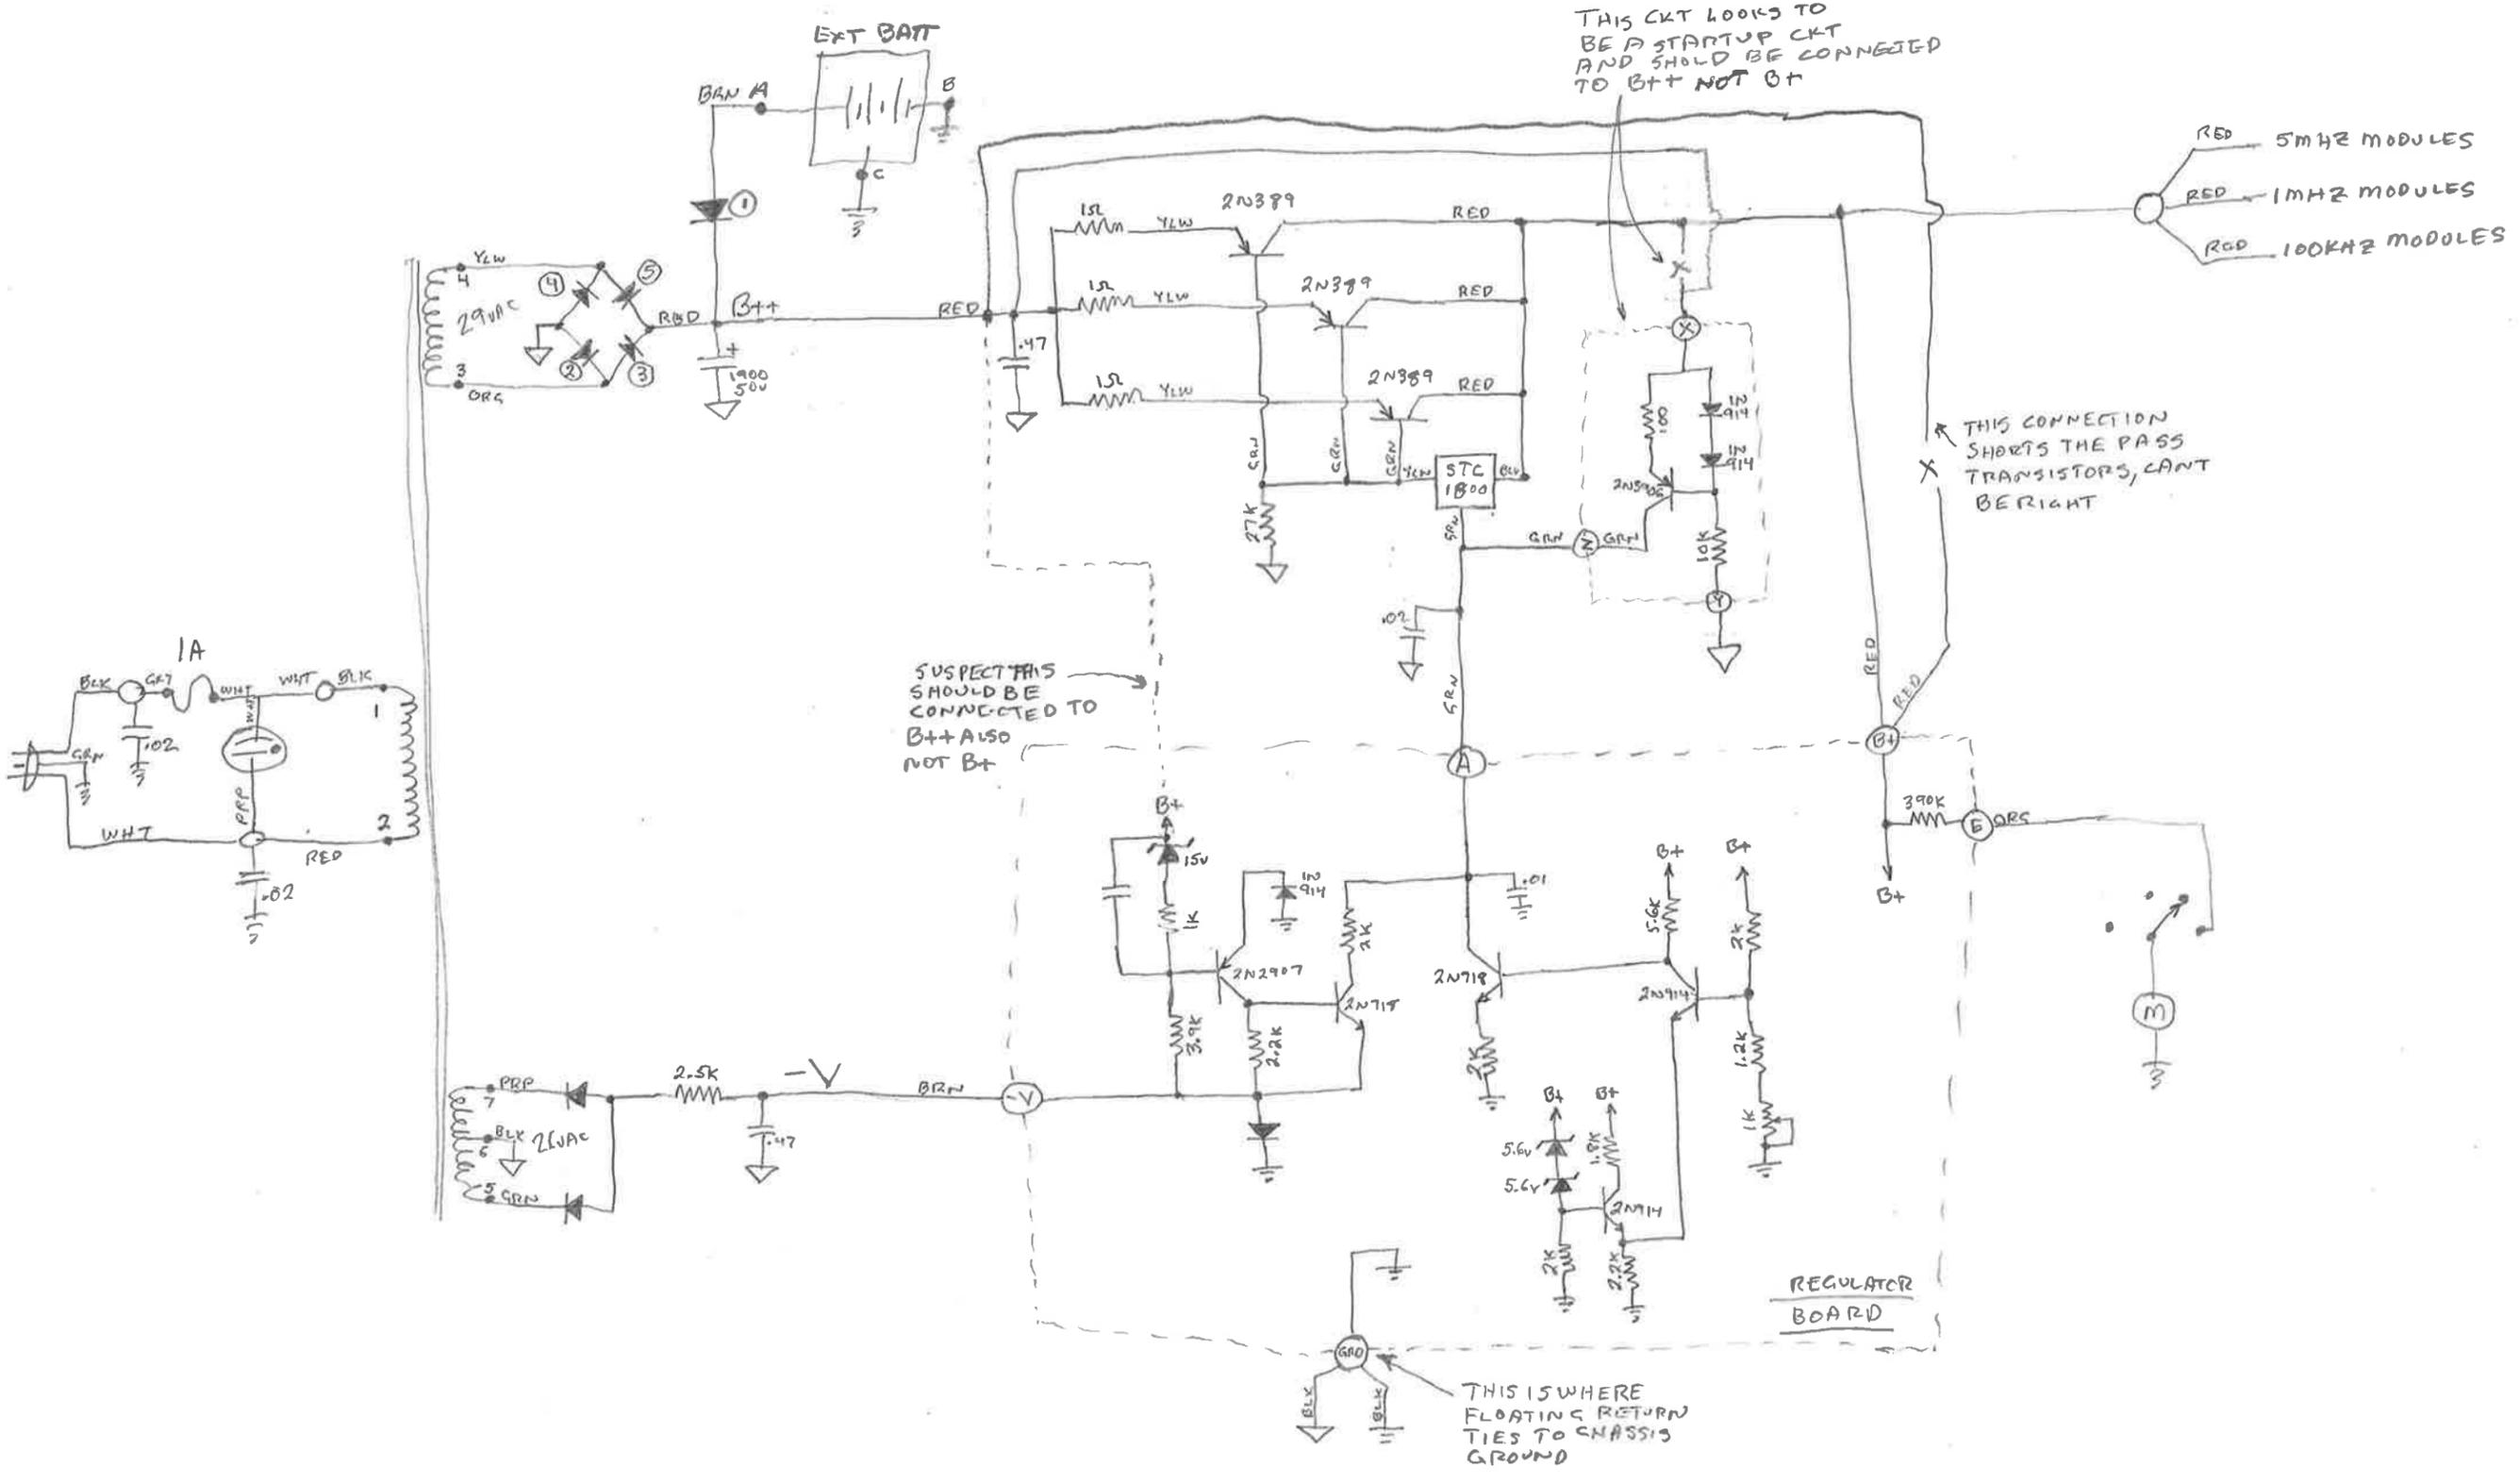
THIS CKT LOOKS TO BE A STARTUP CKT AND SHOULD BE CONNECTED TO B+ NOT B+

SUSPECT THIS SHOULD BE CONNECTED TO B++ ALSO NOT B+

THIS CONNECTION SHORTS THE PASS TRANSISTORS, CANT BE RIGHT

THIS IS WHERE FLOATING RETURN TIES TO CHASSIS GROUND
